# Challenges in implementing smart field tank's level Free Space Radar online & how it helps eliminate Process Safety Incidence: PETRONAS's Experience

Safety Case  
Symposium 2018  
Singapore

# Implementation of IPF (Instrumented Protective Function) Study Recommendation PETRONAS Refinery

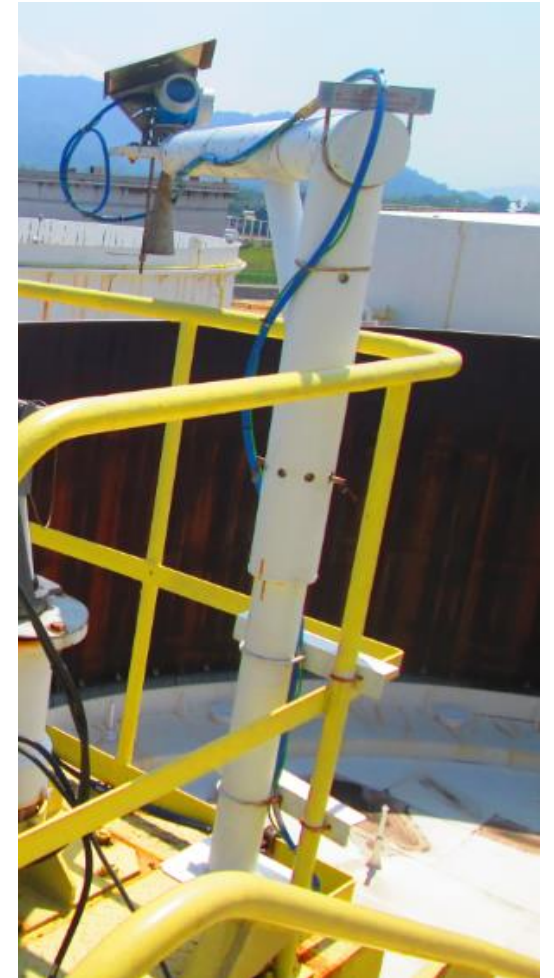
# Implementation of IPF Study Recommendation PETRONAS Refinery (Continued) CASE B: AS LEFT for Floating Roof Tanks

Solution 2: Cost savings more than **RM6mil** by  
Installing safeguarding level transmitter using support at  
the edge of the tank rim and use floating roof surface as  
the target level without having to shutdown the tank

20 nos of Floating  
Roof (Target at  
Floating Roof)

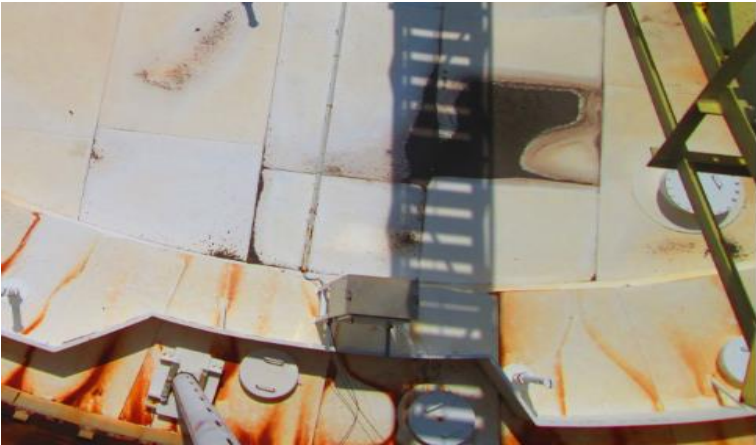
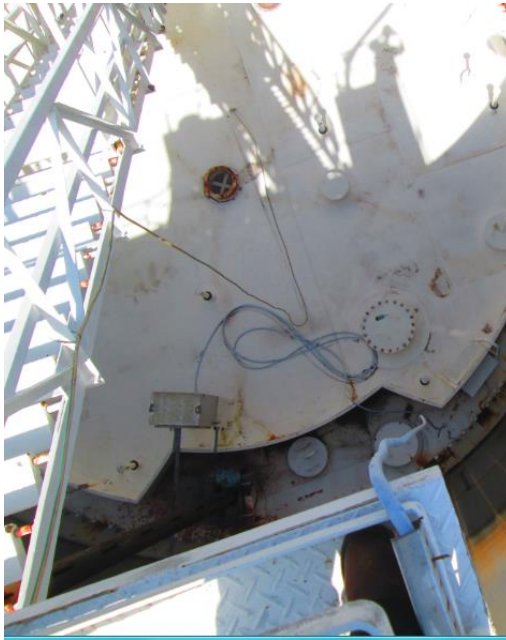
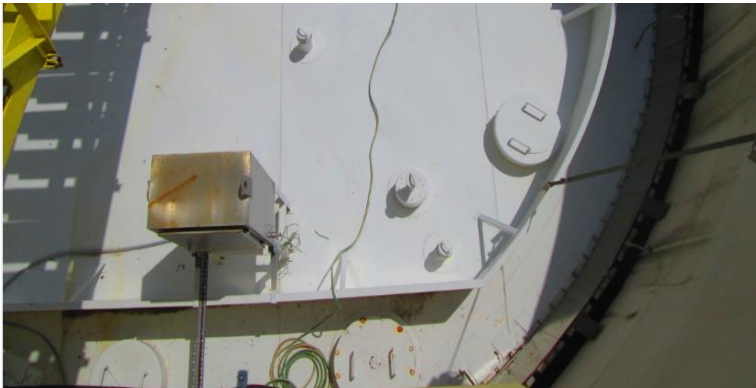
# Root Cause Analysis for floating Roof issues

- a) Disturbance on Reflected Echoes Due to multiple *Dynamic Obstruction* on Target Surface on top of the roof
- b) Not fully secured free Space Radar support/stanchion that can create minimum rotary movement

Sample of actual TARGET on Floating Roofs with Free Space Radar Transmitter installed @ 3m from the Tank Wall:

- a) Install Reflector to guarantee a good target & stronger Reflected Echo (RE) as compared to RE from obstruction which cannot be mapped as it moves together with the roof (Dynamic Obstruction)

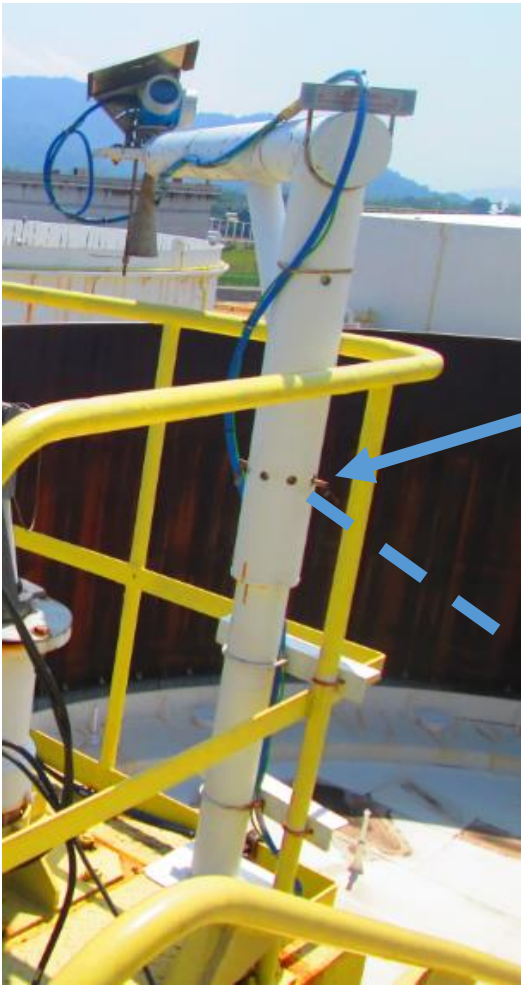
Bigger Hole than the Pin can cause Minimum rotary Movement and thus potential in creating changes/deviation in reading

- b) Secure with support/stanchion (by Threaded, Tapered, and with Lock Nut Type) of the Floating Roof Radar Level Transmitter

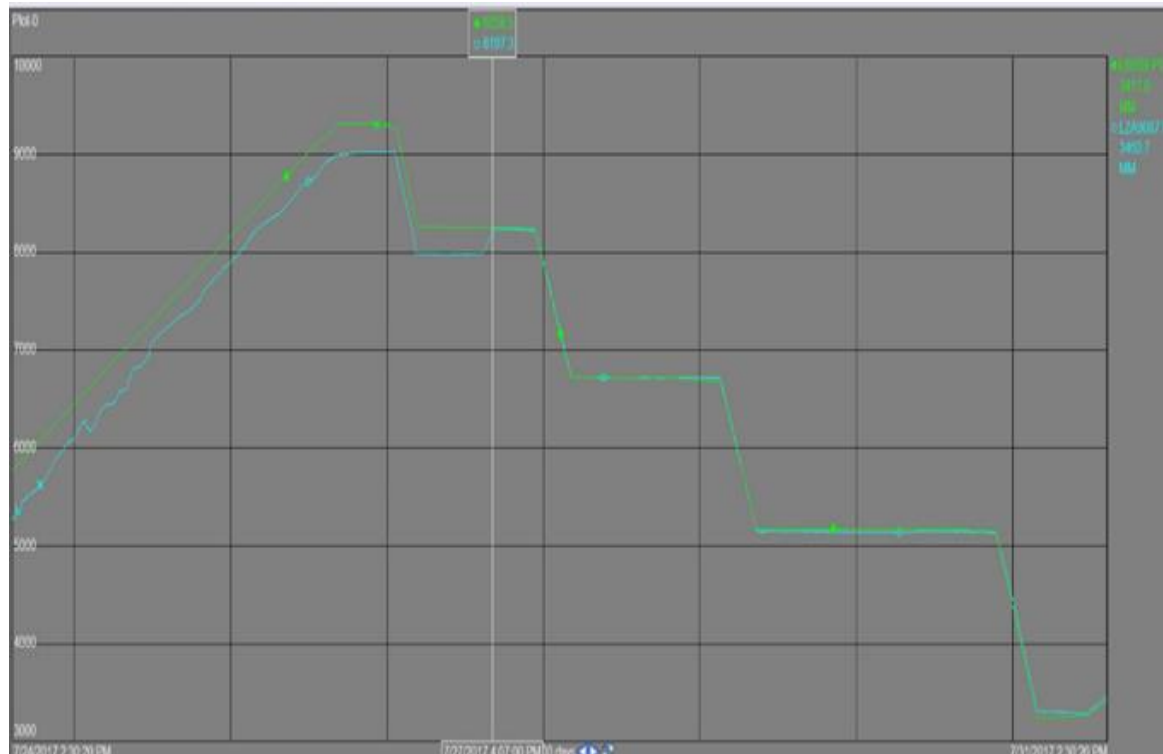
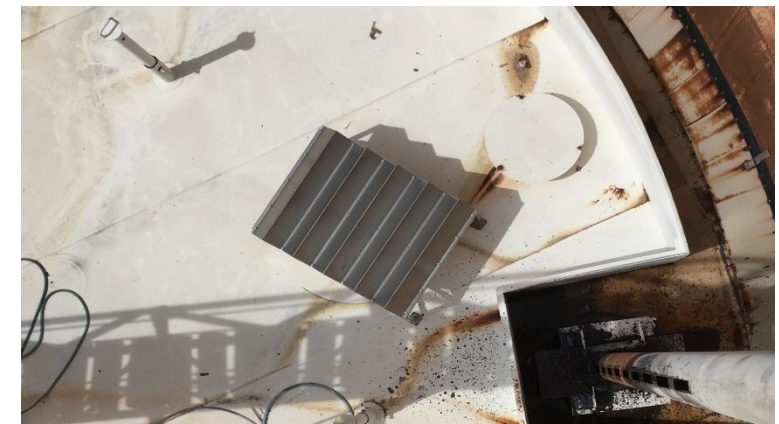
# After Installation of Reflector on floating roof top for 20 nos of tanks

BEFORE

AFTER

Shown  
1 tank

Legend: Green – Control/Monitoring Sensor/Transmitter  
Blue – Safeguarding Sensor/Transmitter
